# FEASIBILITY OF ALTERNATIVES TO THE GOAT ROCK STATE BEACH JETTY FOR MANAGING LAGOON WATER SURFACE ELEVATIONS

Prepared for  
Sonoma County Water Agency

March 10, 2017

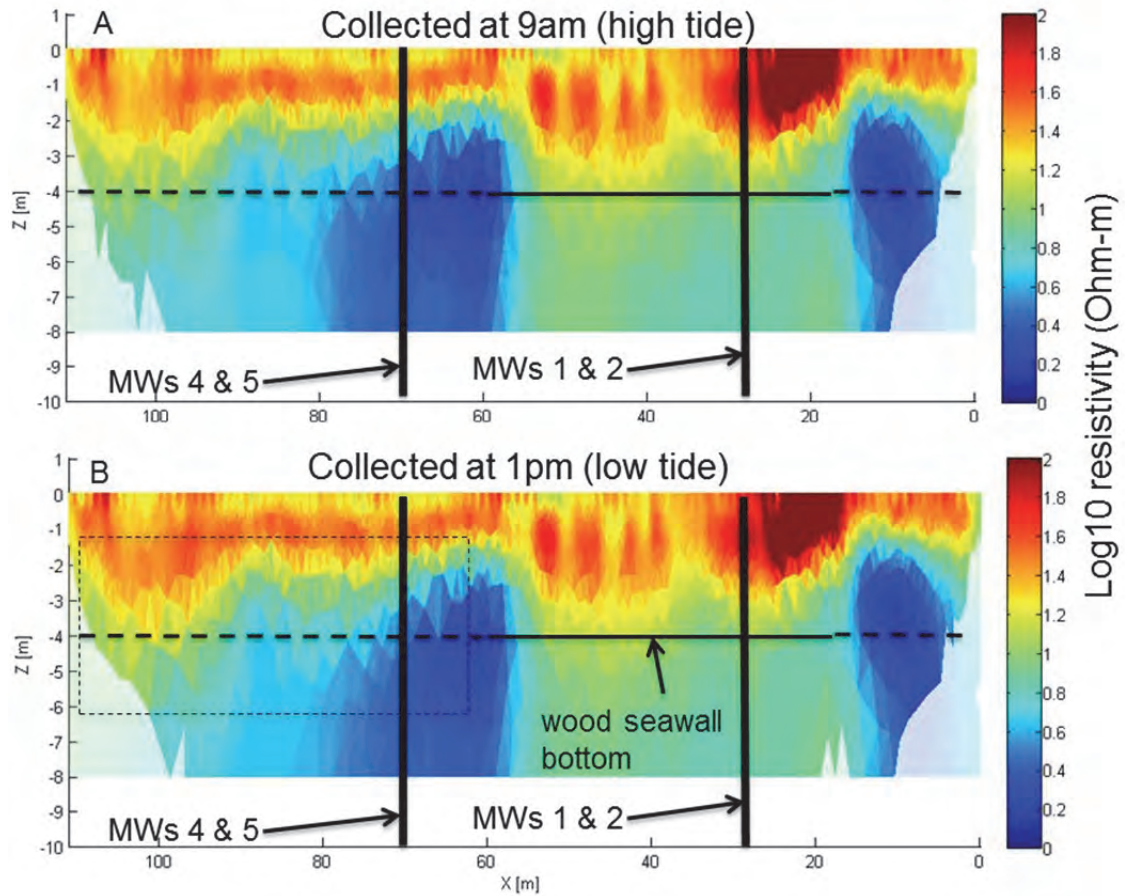
Figure 5. Surface ERT cross-sections collected at (A) high tide and (B) low tide. The horizontal line (-4m) indicates the bottom of the wood seawall, dashed represents no surface exposure and solid exposed at the surface. MWs 1 and 2 are located in the zone of exposed seawall and MWs 4 and 5 in the zone of no exposed seawall. Fresh water (red to yellow) is perched on top of salty/brackish water (light green to dark blue).

Two time snapshots were selected for comparison in Figure 5: (1) ERT response at high tide, and (2) ERT response at low tide. The 2D cross-sections are shown in log<sub>10</sub> resistivity (Ohm-m), so a value of 1 = 100 Ohm-m. Hot colors (red to yellow) indicate more freshwater, and cool colors (light blue to blue) indicate more saline water. The results in Figure 5 show clear evidence of freshwater perched on top of the saline water to a rough depth of -3 to -4 m below grade surface

(yellow-green transition). From 18 to 58 m along the ERT profile, the freshwater extends deeper where the wood seawall is intact. The black line at -4 m represents the estimated bottom of the seawall. The dashed portion indicates where the seawall is not exposed at the surface, and, conversely, the solid line indicates the seawall is exposed at the surface. The locations of the monitoring wells are also indicated in Figure 5 as black vertical lines. Where the seawall is exposed, freshwater extends deeper. Where the seawall is not exposed at the surface, saline water appears shallower. The change between high and low tide in Figure 5 is not readily apparent.

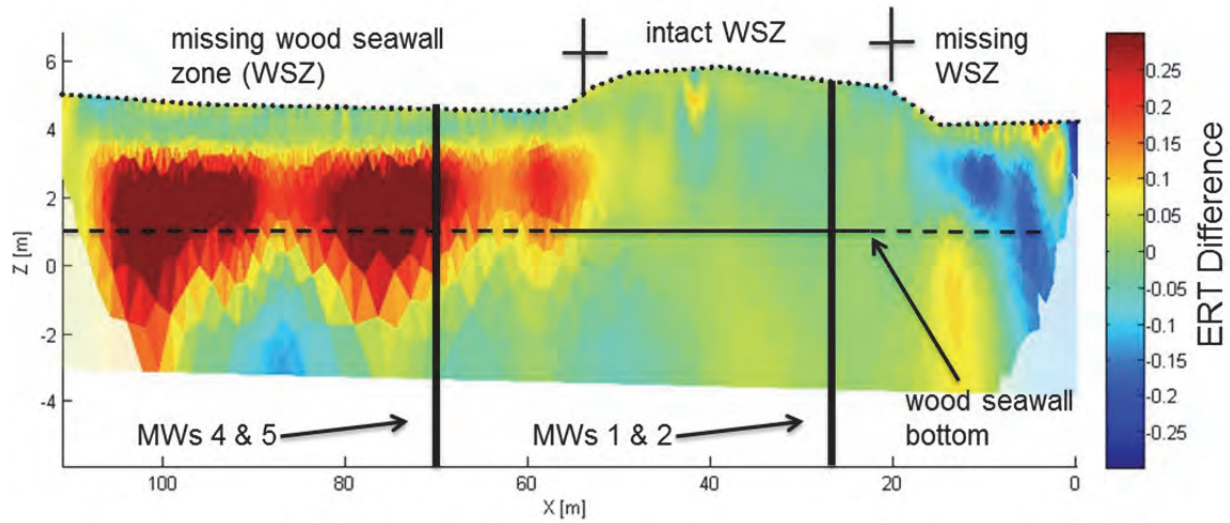
Figure 6. Surface ERT difference (Figure 5 panel A subtracted from panel B) cross-section. The horizontal line (1m msl) indicates the bottom of the wood seawall, dashed represents no surface exposure and solid exposed at the surface. MWs 1 and 2 are located in the zone of exposed seawall and MWs 4 and 5 in the zone of no exposed seawall. ERT difference in decimal of percent (i.e. 0.25 = 25% change), red colors indicate increase of fresh water (more resistive) and blue increase in saline water (more conductive).

To further investigate the permeability of the beach in this zone, the two ERT data sets from high and low tides were simply differenced from each other after inversion (Figure 6). In Figure 6, topography was applied. The y-axis represents elevation in NGVD29 m. Red to yellow colors indicate an increase in fresher water (increased resistivity), and blue represents an increase in saline water (decreased resistivity). Between 58 m and the end of the profile up to 25% change in resistivity occurs, caused by the influx of freshwater in the zone of MWs 4 and 5, where the seawall is missing. Little to no change in resistivity was observed where the seawall was intact at MWs 1 and 2, indicating less hydraulic connectivity in this zone.

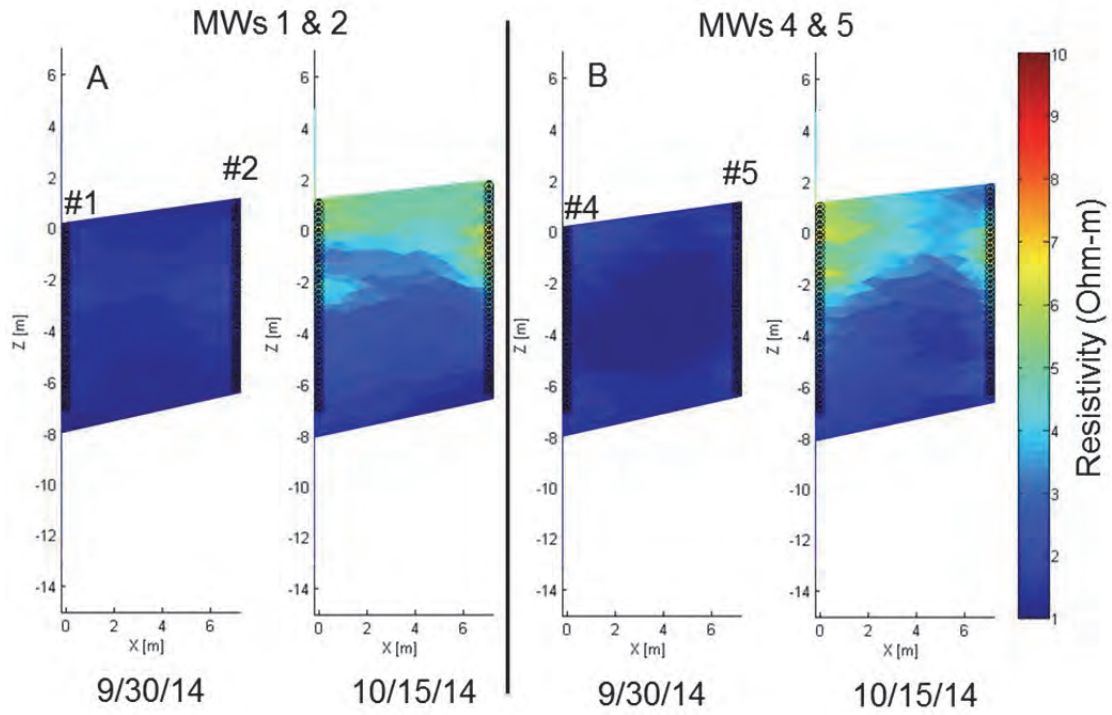
Figure 7. Cross-well ERT cross-sections collected between MWs 1 and 2 and MWs 4 and 5 at two estuary elevations. On September 30<sup>th</sup> estuary stage is at 1.82 m above msl, and on October 15<sup>th</sup> 2.4 m above msl. Cool blue colors indicate saline water, and light green to red colors indicate more fresh water infiltration on October 15<sup>th</sup>.

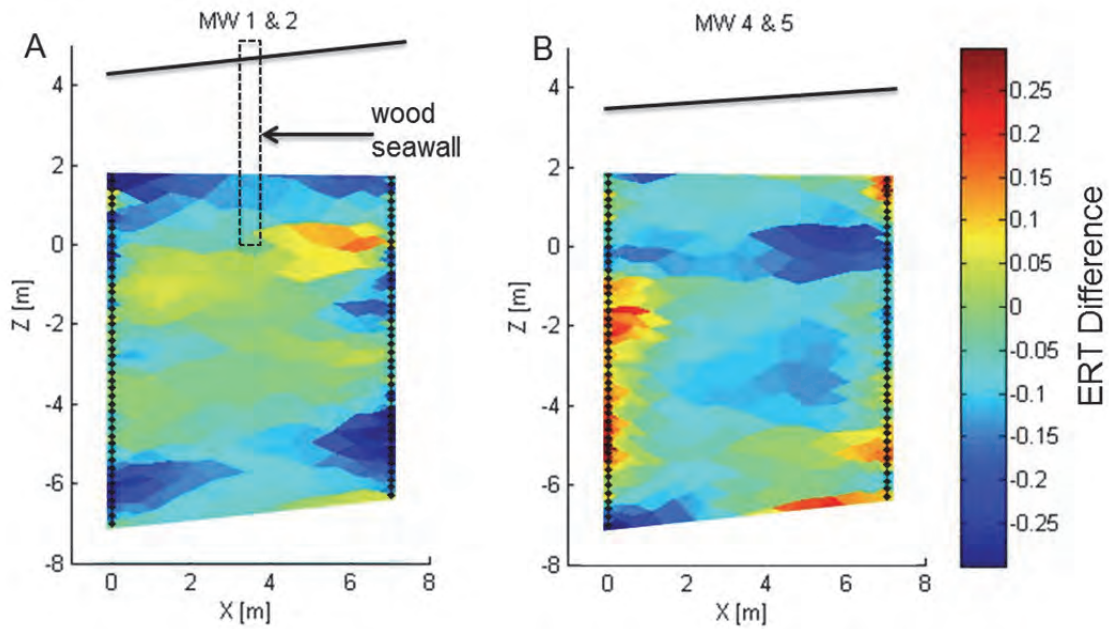
Figure 8. Cross-well ERT difference from low tide to high tide on October 15<sup>th</sup>, 2014, between MWs 1 and 2 (exposed seawall) and MWs 4 and 5 (no exposed seawall). ERT difference in decimal of percent (i.e. 0.25 = 25% change), red colors indicate increase of fresh water (more resistive) and blue increase in saline water (more conductive). Little to no change is observed between MWs 1 and 2 compared to an average 15% change between MWs 4 and 5.

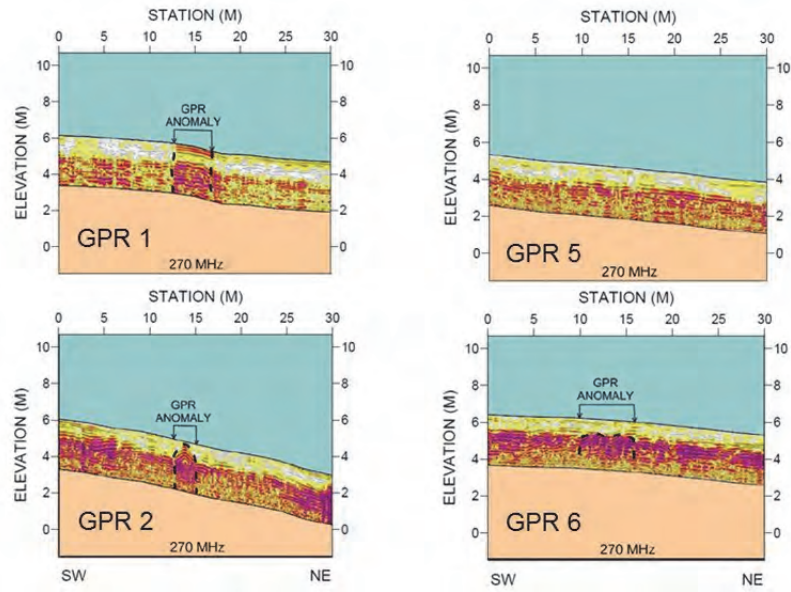
Figure 10: Selected GPR profiles from the areas of interest to investigate the condition of the jetty and support elements. High amplitude reflections are in pink to purple. GPR data collected with 270 MHz antennae.

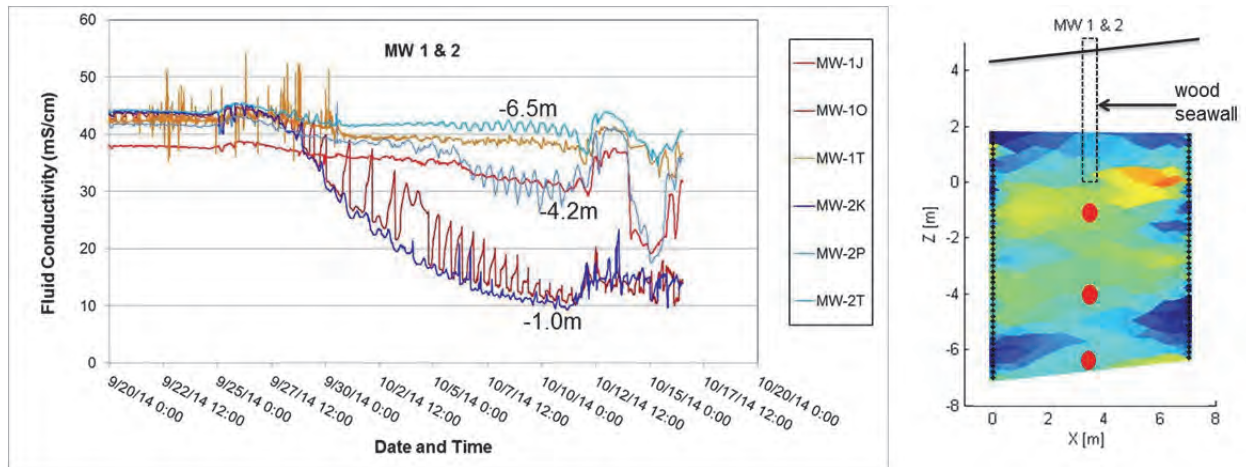
Figure 11: Graph showing raw fluid conductivity from salinity sensors in MWs 1 and 2 at -1.0 m, -4.2 m, and -6.5 m NGVD. The red dots on the ERT cross-well section show the location represented by the salinity sensors. Sinusoidal patterns at each sensor are the result of tidal action rising and falling. River mouth closure occurs on 9/29/15 and ensuing fresh-saline water stratification occurs.

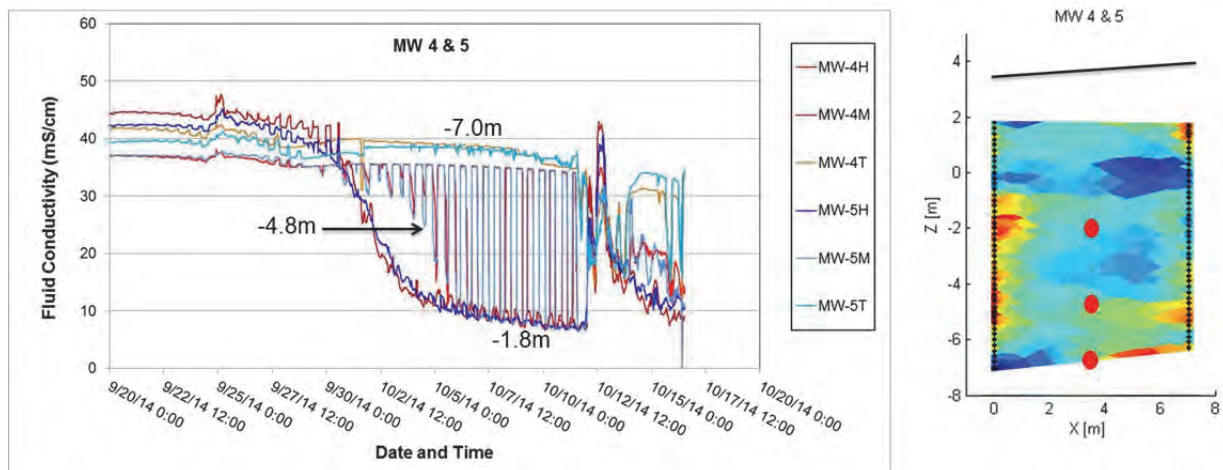
Figure 12: Graph showing raw fluid conductivity from salinity sensors in MWs 4 and 5 at -1.8 m, -4.8 m, and -7.0 m NGVD. The red dots on the ERT cross-well section show the location represented by the salinity sensors. Sinusoidal patterns at each sensor are the result of tidal action rising and falling. River mouth closure occurs on 9/29/15 and ensuing fresh-saline water stratification occurs.

By comparison, both of these are considerably muted compared to the intermediate (-4.8 m) salinity sensors in MWs 4 and 5 shown in Figure 12. During tidal changes, the intermediate level flips back-and-forth between 10 and 38 mS/cm as the tide rises and falls. This indicates a much faster conveyance of water at the same depth interval compared to MWs 1 and 2. On October 12<sup>th</sup> (see Figure 12) a wave apparently over-washed the beach, and saline water infiltrated vertically, causing the stratified fresh-saline water to collapse. All sensors increase briefly to higher salinity, then the fresh-saline water promptly re-stratifies. To look at the response time between tidal changes and salinity sensors, the four intermediate levels are plotted along with daily tidal changes. At MWs 4 and 5, the tide influences the well data very quickly, with sensors in both wells (gold and green lines, Figure 13) peaking with peak tide (saline water intrusion) and bottoming at low tide (fresh water intrusion), and then repeating (i.e., minimal lag time between sensor peaks). Comparatively, the responses in MWs 1 and 2 are extremely muted with almost no infiltration of fresh water, even though they are at the same depths at MWs 4 and 5. The salinity trends, along with temperature trends (not shown), are used to estimate horizontal and vertical seepage.

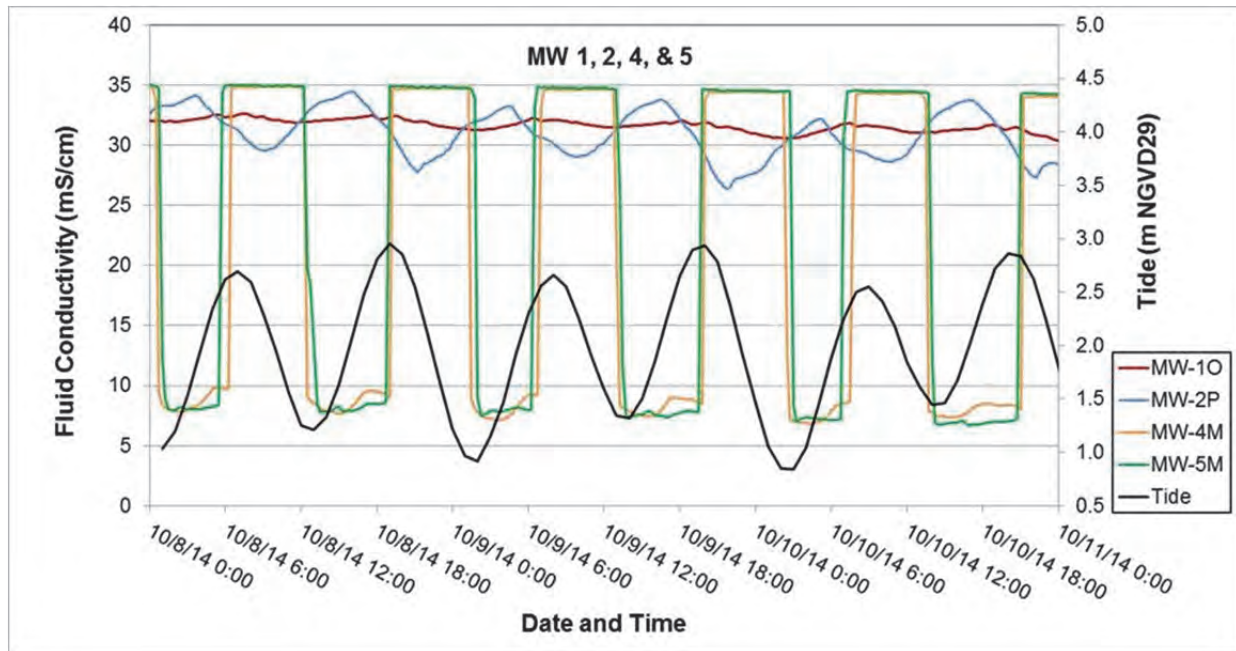
Figure 13: Fluid conductivity in MWs 1, 2, 4, and 5 with daily tides. At MWs 4 and 5 (gold and green lines, respectively) very little lag between peak and trough of salinity signal and matches tidal cycles. MWs 1 and 2 sensors have very little to no amplitude comparatively and a phase shift.
